BRIDGING THE IMJIN

CONSTRUCTION OF LIBBY AND TEAL BRIDGES DURING
THE KOREAN WAR (OCTOBER 1952 – JULY 1953)

Studies in Military Engineering
Number 5

OFFICE OF HISTORY
UNITED STATES ARMY CORPS OF ENGINEERS
FORT BELVOIR, VIRGINIA
1989

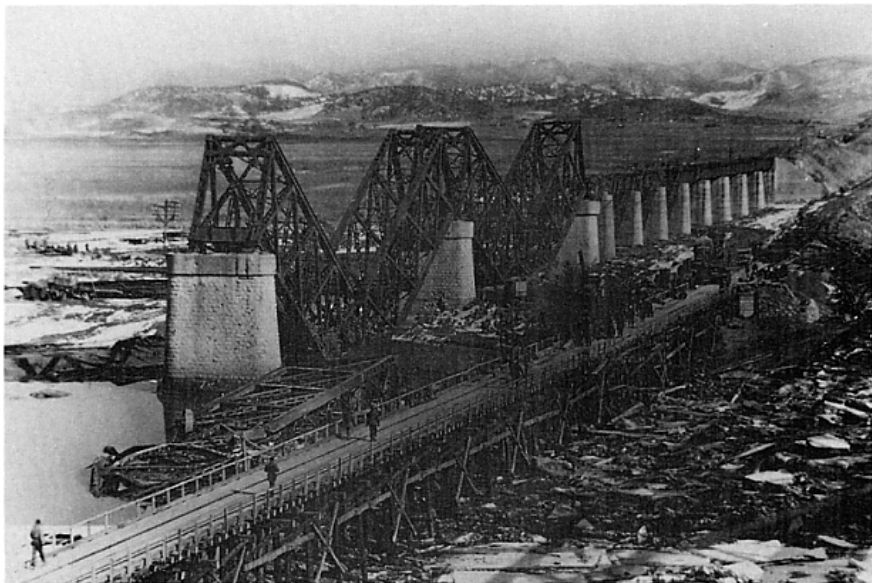
Figure 7. The low-level pile bridge at the Freedom Gate site that the 84th Engineer Construction Battalion erected in January–February 1952 between two destroyed railway spans. The shadow cast by the more southerly of the railway bridges, which the 84th would reopen in July 1952, is visible at the right of this 10 March 1952 photo.

Assigning two companies and devoting over 140,000 man-hours to this project, the battalion made rapid progress and was able to open the bridge on 15 February. (Figure 7) Six days later friendly aircraft mistakenly bombed the bridge and damaged seven bents. The 84th replaced all of the damaged bents except one which stood dangerously close to an unexploded 1,000-pound bomb that could not be removed. That area was spanned by a 36-inch I-beam supported on specially braced bents.²⁰

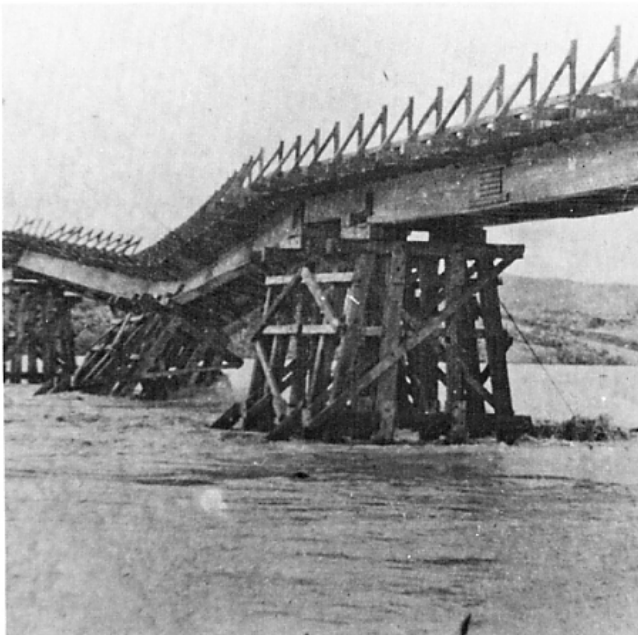
Figure 12. The high-level Teal bridge collapsing under the pressure of floodwater on 30 July 1952.

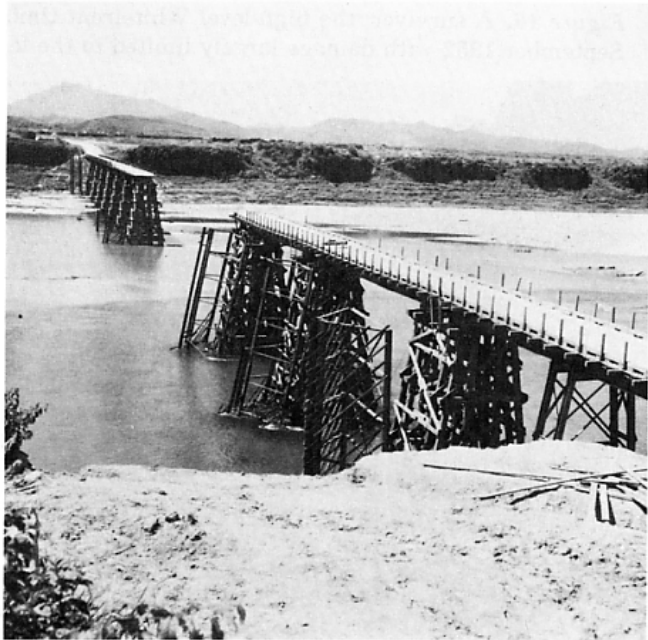
Figure 15. The high-level Teal bridge after the flood of 24-25 August 1952.

An even greater flood roared down the Imjin on 24 and 25 August, fed largely by rains that fell in North Korea. Raising the Imjin 40.5 feet in ten hours at Pintail, these waters destroyed the Widgeon bridge and swept away additional piers of the Teal and X-Ray bridges. (*Figure 15*) This was the year’s last significant flood on the Imjin. At the end of the 1952 flood season, the I Corps engineer observed with some satisfaction that three high-level bridges—at Whitefront, Pintail, and Freedom Gate—had survived the summer unscathed, and each supported a different division across the river. (*Figure 16*) But more than 16 miles separated the Freedom Gate and Pintail bridges, and this stretch of open river could have threatened the U.N. forces if the enemy had launched a serious offensive in August 1952.³¹

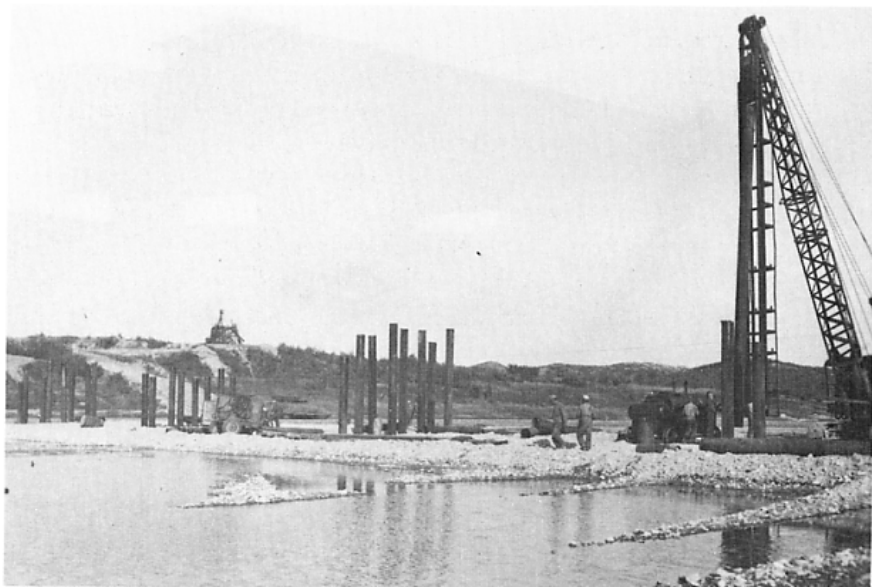
Figure 20. Engineers driving 16-inch Armco steel-column piles for the low-level Teal bridge in October 1952.

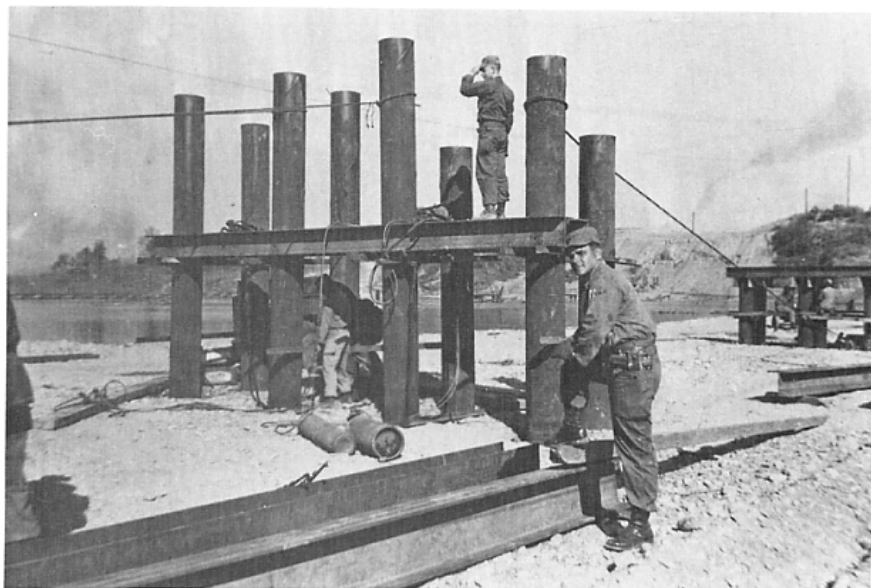
Figure 21. Cables used to align piles that had “walked” when driven against large boulders in the riverbed.

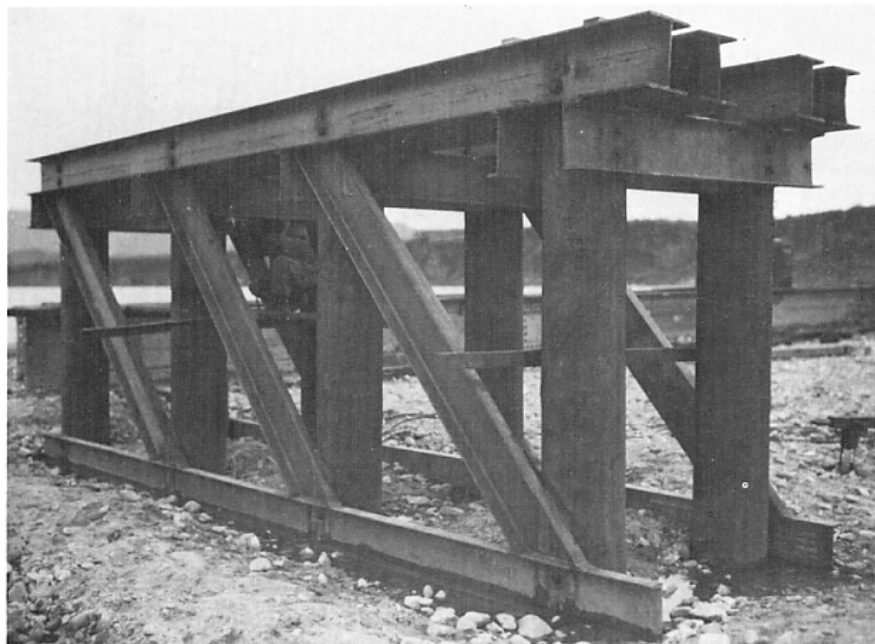
Figure 22. A nearly completed pier featuring diagonal channel-iron bracing.

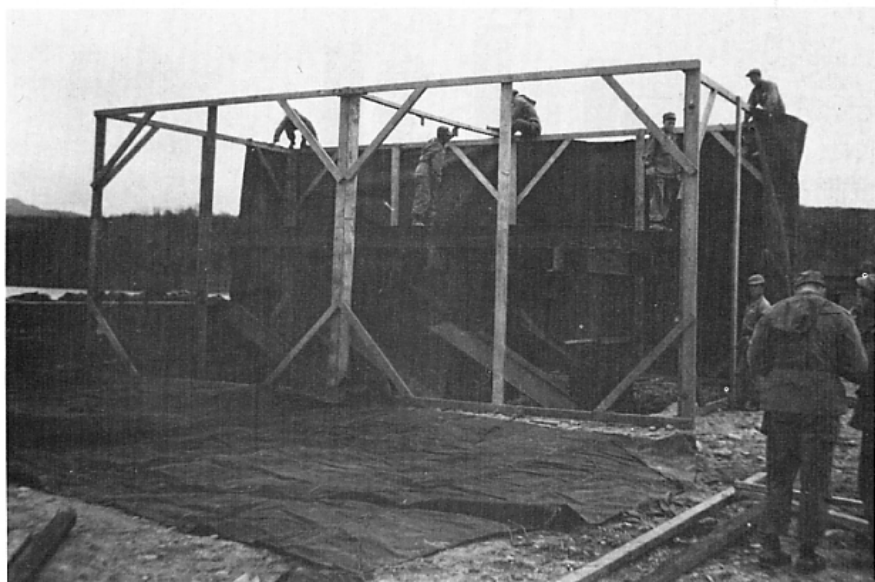
Figure 23. Troops constructing blackout shelters for night welding that could double as curing cabins in cold weather.

keep an arc. Nighttime, with the necessity for working in as much blackout as possible and the usual decrease in temperature, aggravated these difficulties. To meet this situation, canvas shelters were designed which could be set up around the piers to provide both shelter from the cold and wind and blackout at night. The frames of these shelters were so constructed that they could be taken down and moved as required.⁷ (*Figure 23*)

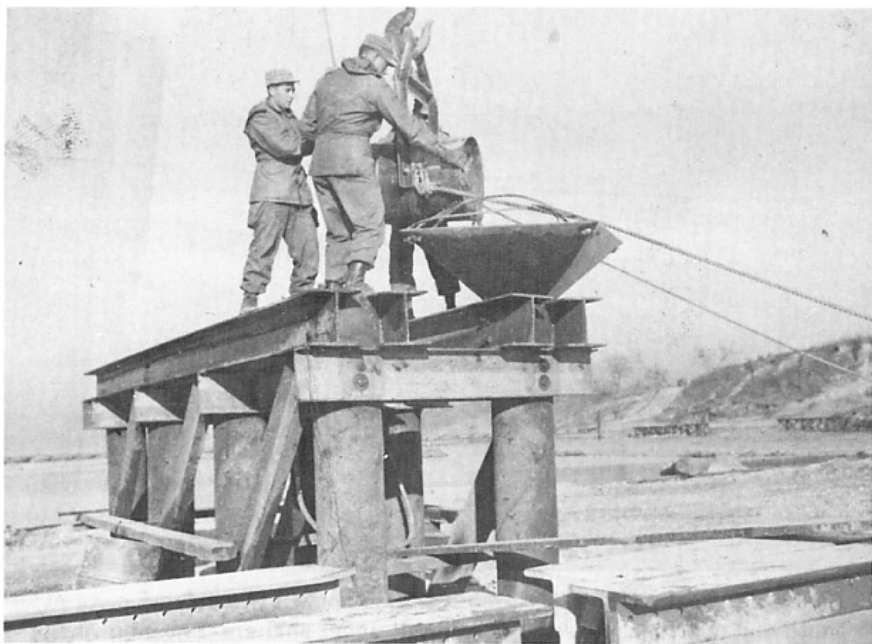
Figure 24. Troops filling the hollow Armco piles with concrete, with 36-inch I-beam girders in the foreground.

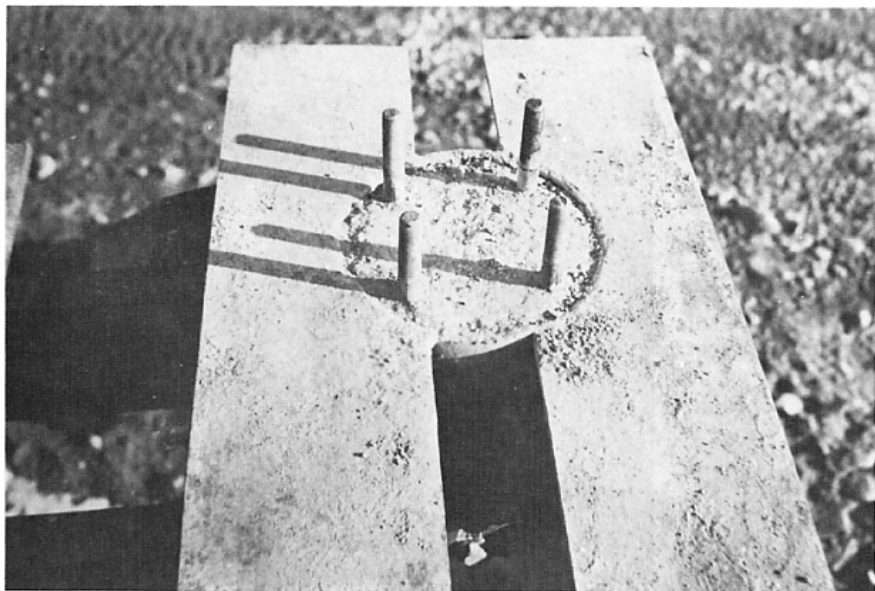
Figure 25. Anchor bolts set in a concrete-filled pile capped by 12-inch H-beams.

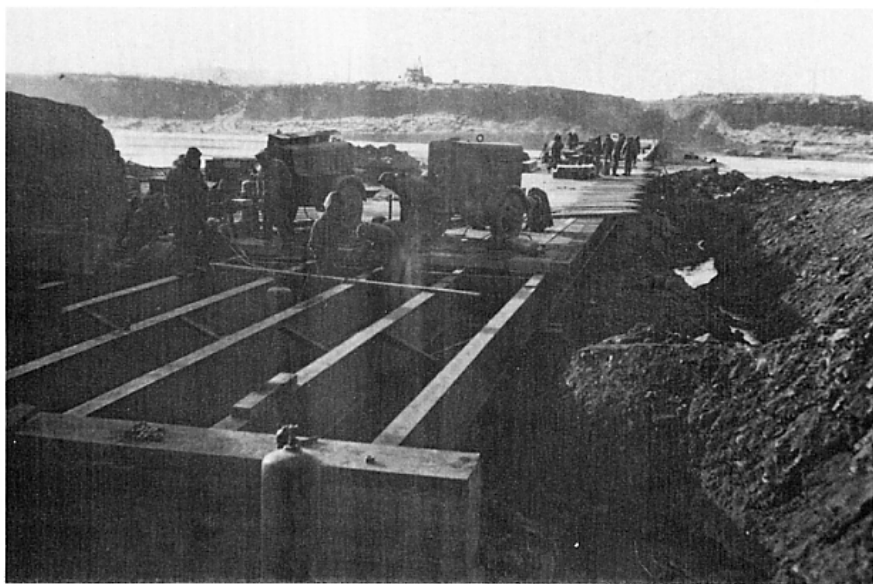
Figure 29. Troops placing decking from pier 16 to the north abutment. This was the only span which used six 24-inch girders. Note angle-iron diaphragming between girders. Visible at center is two-inch by six-inch laminated sub-decking and beyond that is three-inch by twelve-inch diagonal decking.

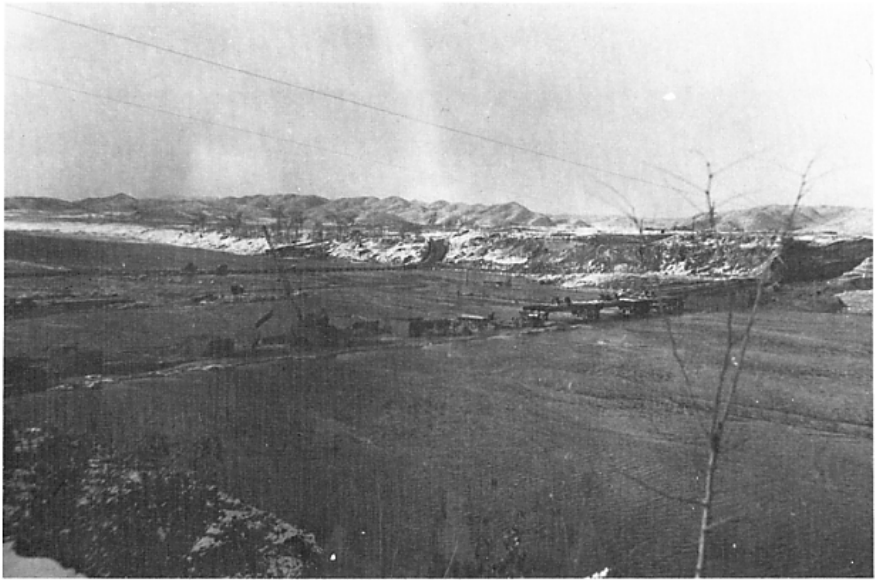
Figure 30. Girders in place on piers 8 through 11 allowing the passage of water below these spans and the construction of a causeway to pier 11 from the north bank.

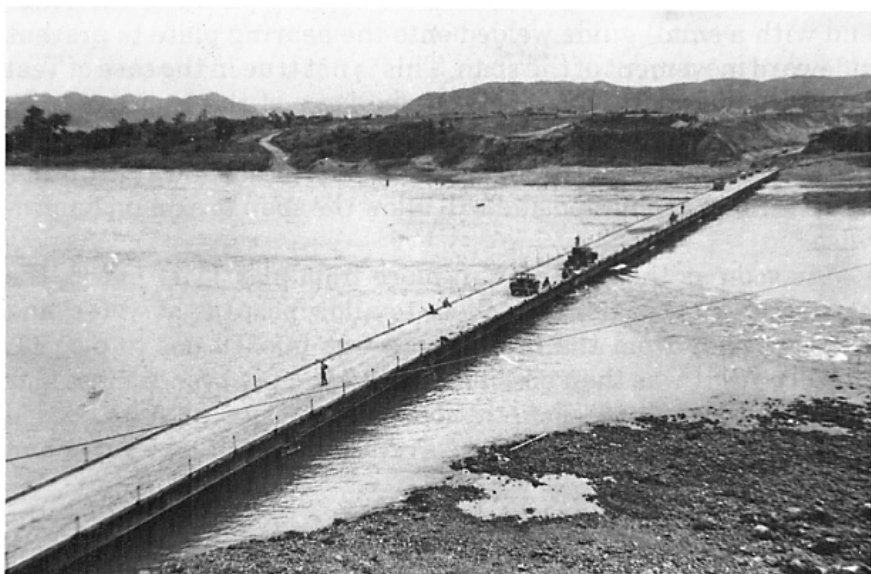
Figure 37. Teal bridge after the flood of 15 July 1953 showing the damage to the removable guardrail, which was not removed due to the rapid rise of the river.

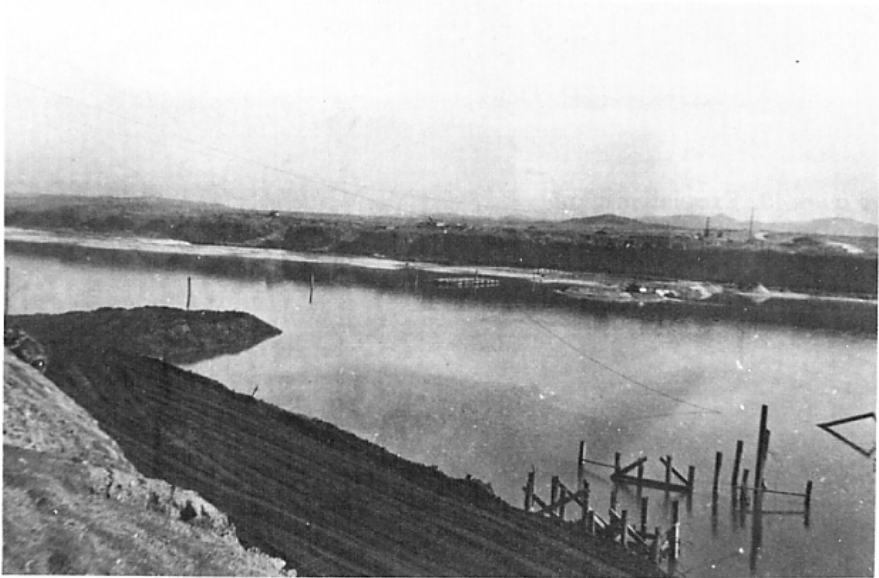
Figure 38. The Imjin River at the X-Ray site, showing early progress on the construction causeway and test piles driven in November 1952 to determine the depth of bedrock.

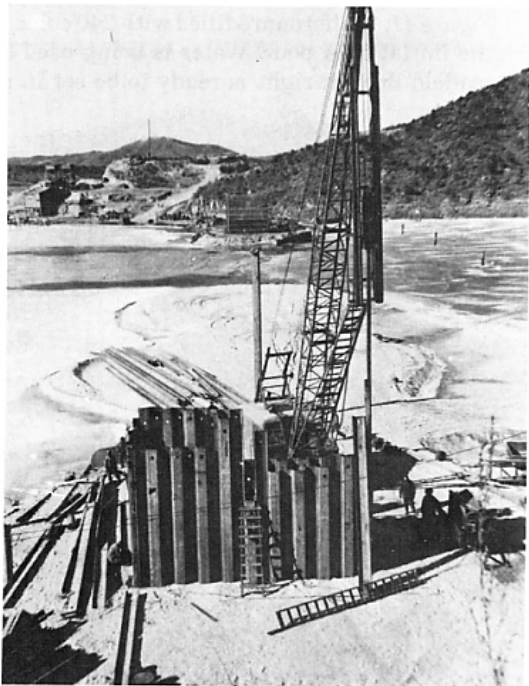
Figure 39. Pile driving on cofferdam 1 during February 1953. View shows curing cabin on pier 6 on far causeway and the concrete batch plant on the far shore.

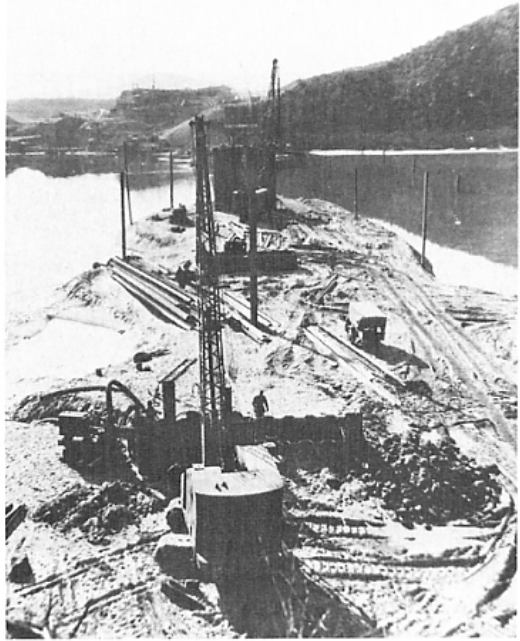
Figure 41. Cofferdam 3 filled with 240 cubic yards of concrete constituting the initial or A pour. Water is being used to cure the concrete, and the scaffold floor at right is ready to be set in place.

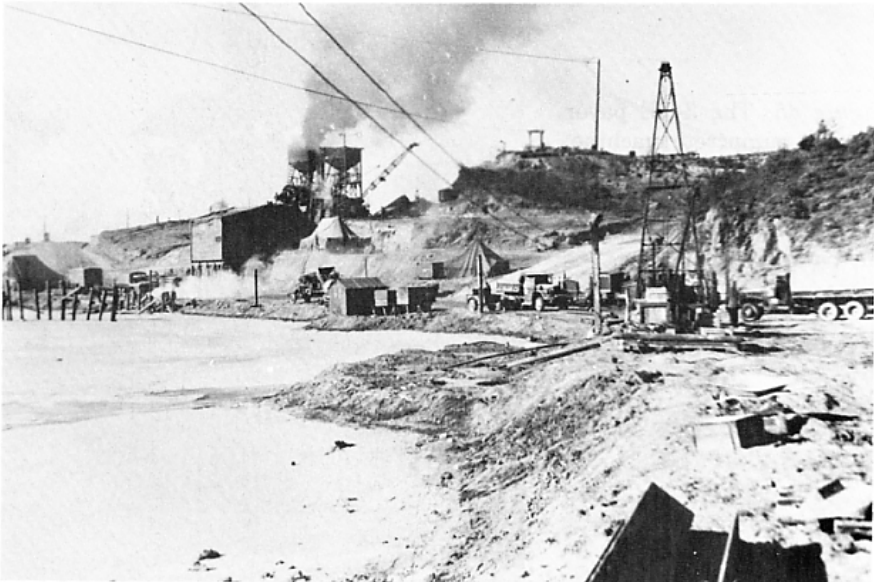
Figure 44. Close-up view of the concrete batch plant showing aggregate bins and, at bottom, locations where dump trucks and mixers were filled.

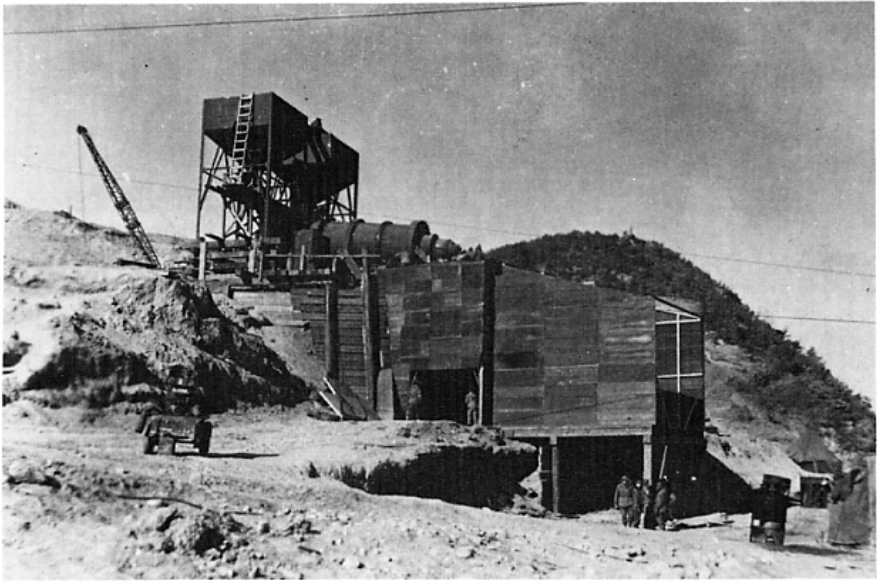
Figure 45. The 34 E paver and Rex pumpcrete machine, which together proved remarkably successful in mixing cement and moving it to the pouring site.

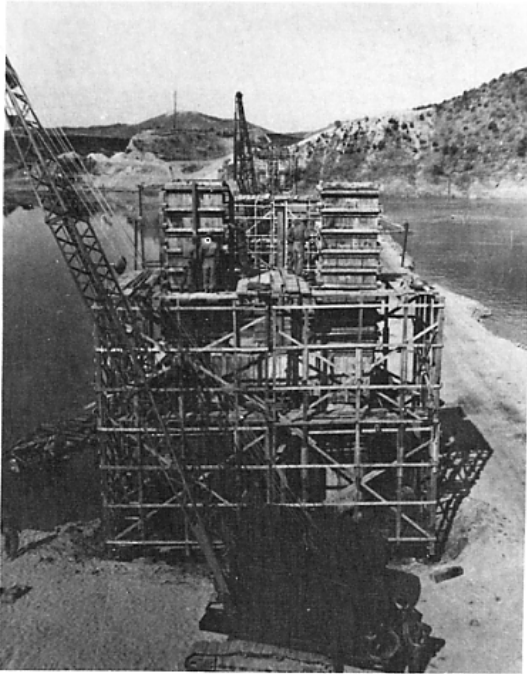
Figure 47. The curing cabin on pier 7 in position for the final or E pour. The canvas pipe, center, provided heat for curing. The 34 E paver and the pump-concrete machine, right, mixed cement and pumped it to the pouring location through the pipe, left, that ran over the curing cabin.

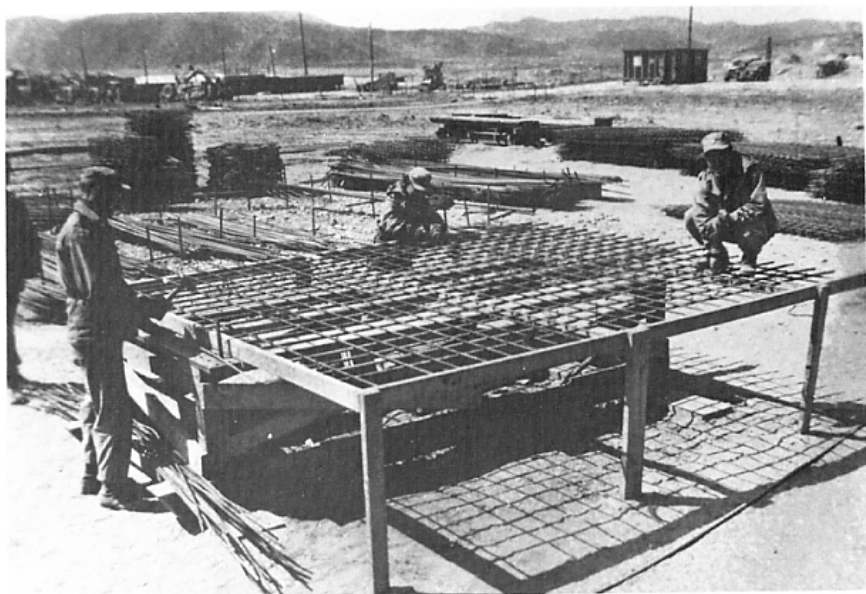
Figure 48. Steel mats that would reinforce the bridge decking being fabricated in the central work yard.

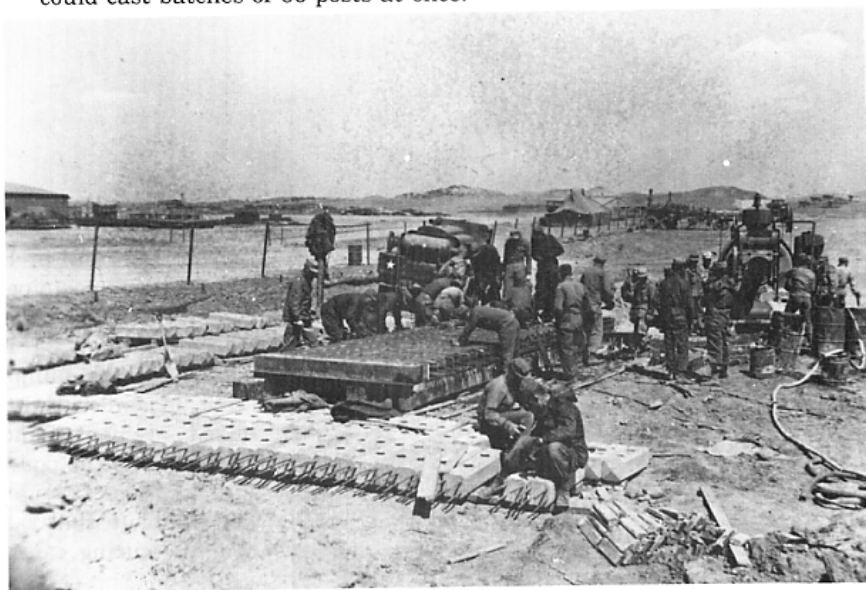
Figure 49. Soldiers casting guardrail posts. The reusable forms shown could cast batches of 66 posts at once.

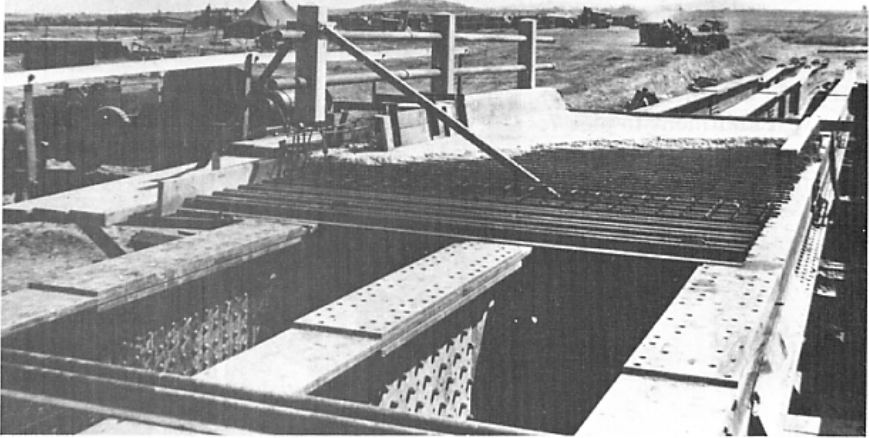
Figure 50. Full-scale model of a section of decking that was built in the work yard for practice and testing purposes.

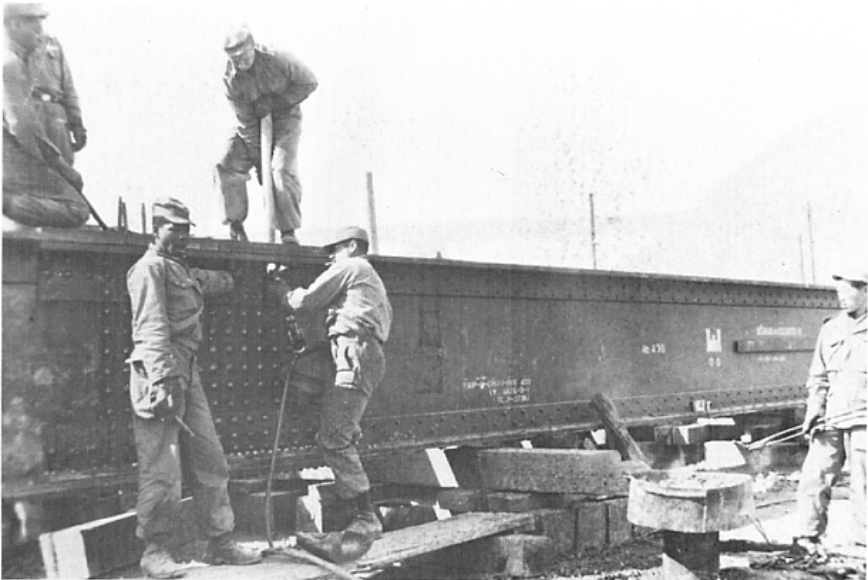
Figure 51. Riveters at work on steel beams. Newly trained American and Korean riveters developed their skills so quickly that a 121-foot span was launched with a deflection of only 17 inches.

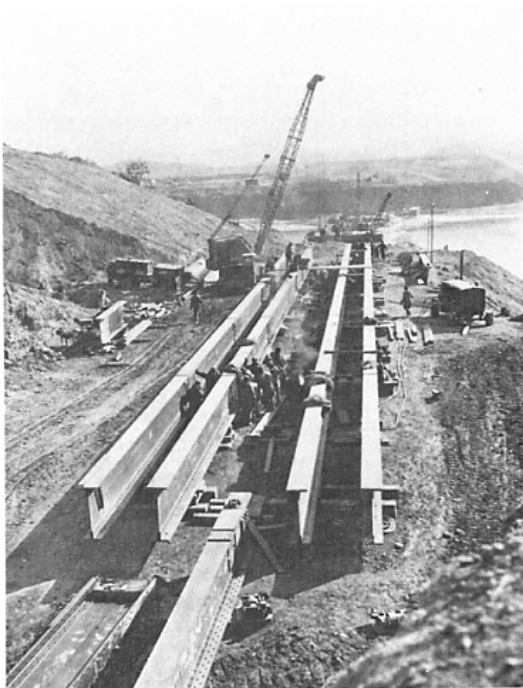
Figure 52. Steel beams being prepared for the span from the west abutment to pier 7, while riveters received training on the beam at left center.

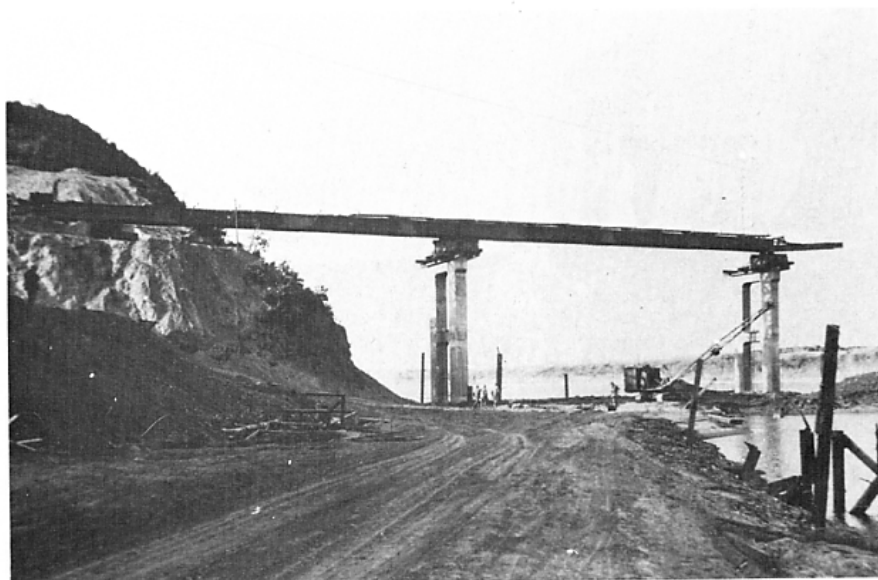
Figure 53. Steel beams in place from the west abutment across pier 8 to pier 7. The 30-foot launching nose may be seen beyond pier 7.

phragmed) with six-by-six-inch angle iron and fifteen-inch channel iron between beams to form a pair of girders as a unit for launching. This downstream pair was then launched with a 30-foot launching nose fixed to the front at an upward angle to compensate for any downward deflection of the beam when it reached the pier, and a counterweight was added to the tail of the girder to prevent tipping. (*Figure 53*)

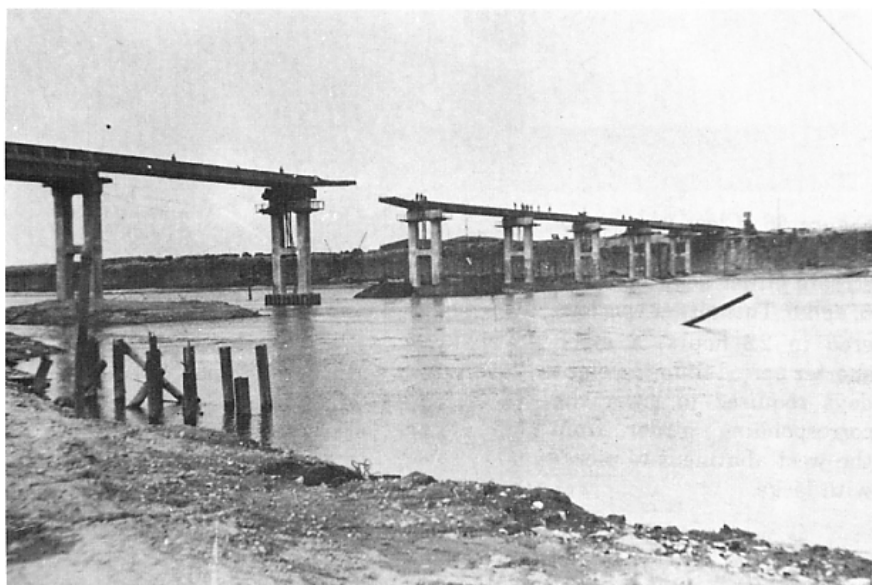
Figure 54. Launching the span across piers 7, 6, and 5. Launching noses extend both east and west into the gap between piers 5 and 6.

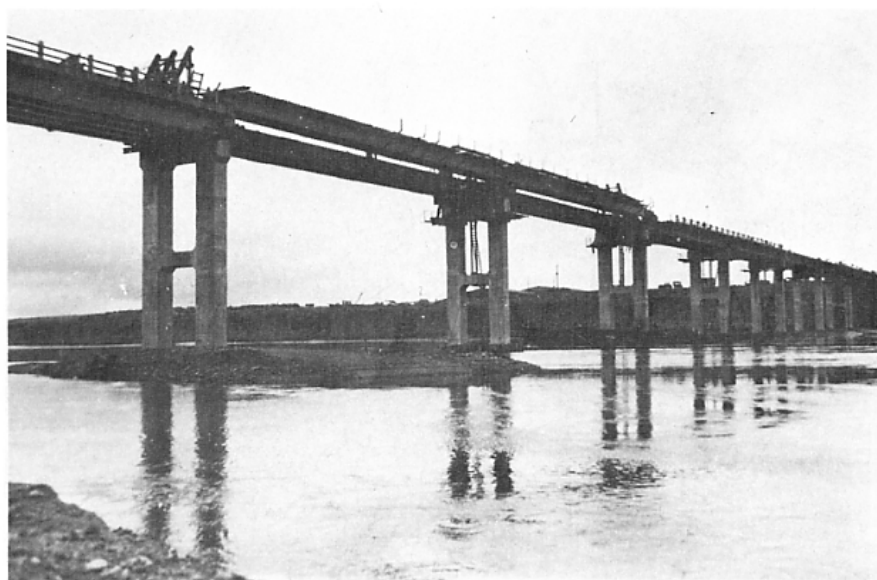
Figure 55. Chain hoist lowering girder complete with sub-decking across piers 7, 6, and 5.

Figure 56. Close-up view of chain hoist lowering downstream girder across piers 7, 6, and 5. This girder was lowered in 22 hours, a much shorter period than the eight days required to lower the corresponding girder from the west abutment to pier 7 with jacks.

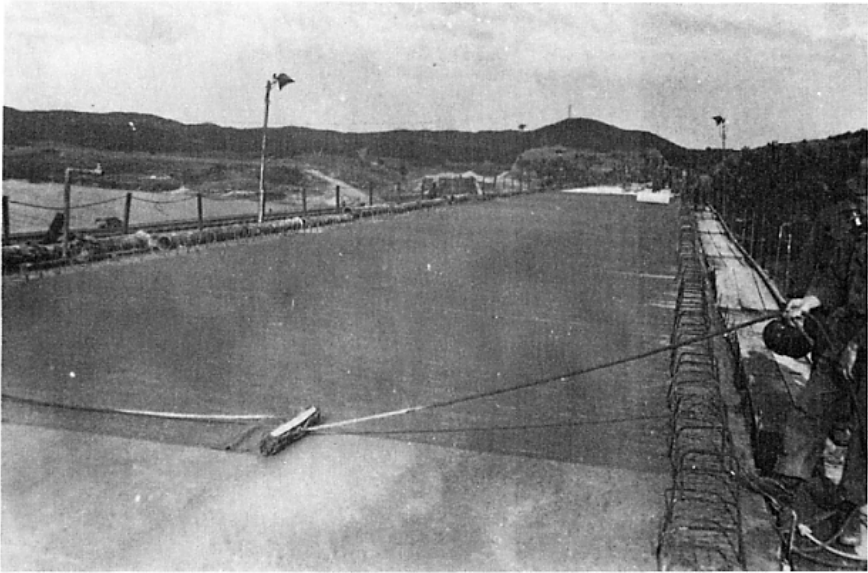
Figure 58. A burlap drag being used to give the deck surface the desired rough texture perpendicular to traffic. Reinforcing steel for curbing is visible.

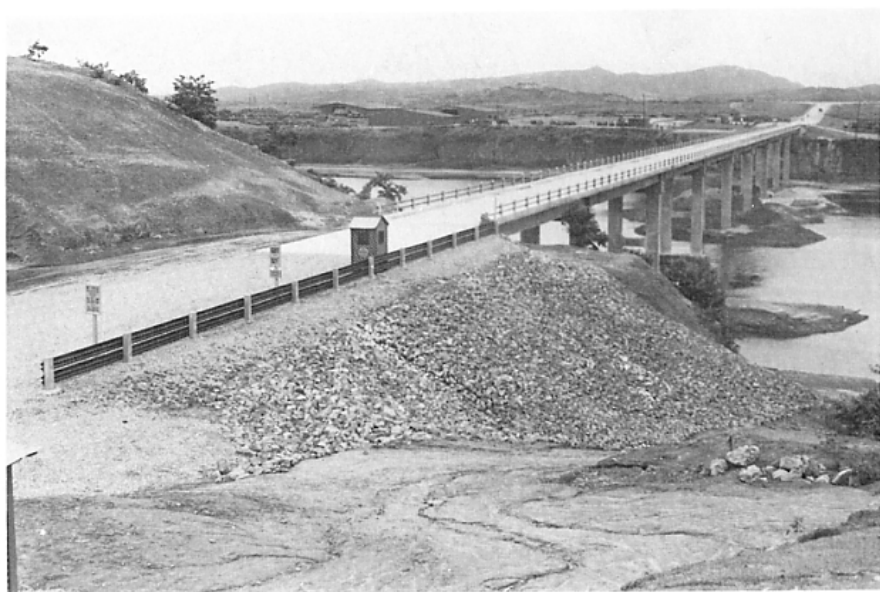
Figure 59. Concrete deck being covered with burlap, at center, prior to receiving a seven-day water cure. A flood gauge is visible on pier 1 in foreground.

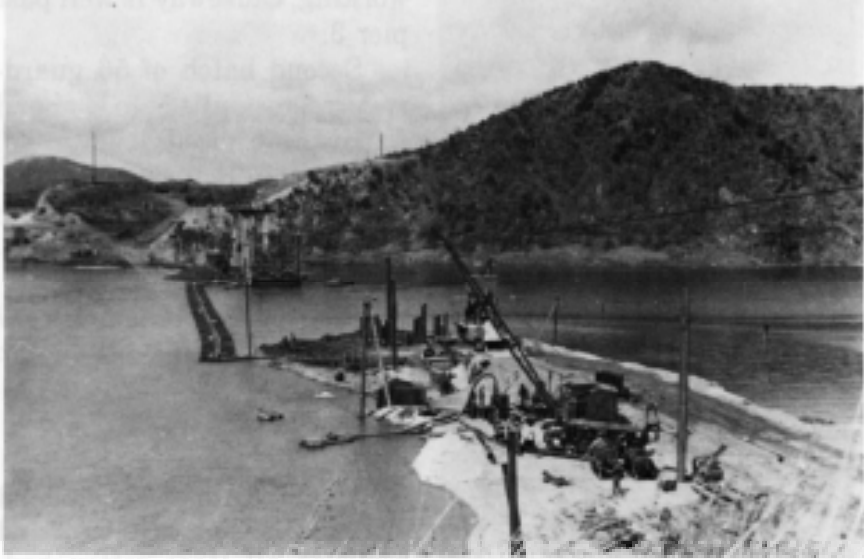
Figure 70. View of the footbridge that enabled the pumpcrete machine to pump concrete from its location near pier 3, at center, to pier 6 across the river channel.

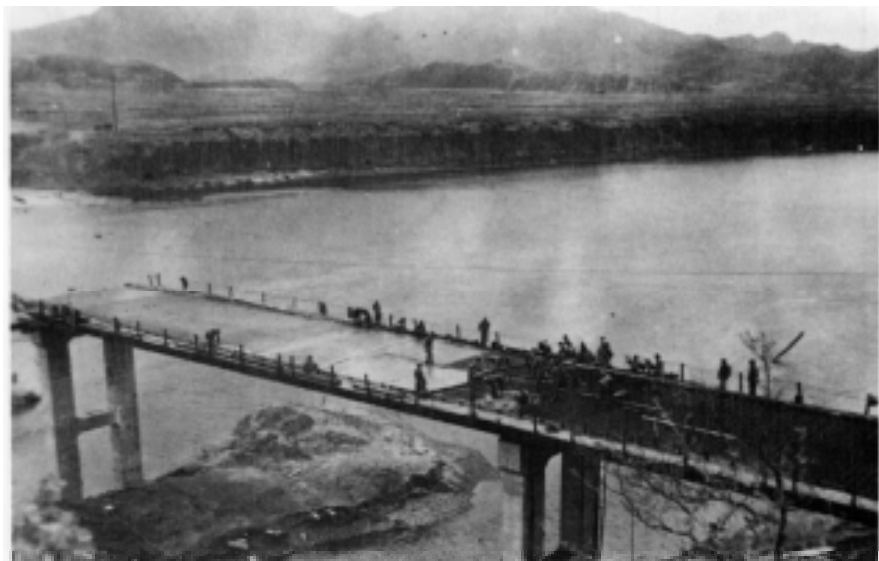
Figure 75. Troops laying the concrete deck. Two steel mats reinforced the concrete to provide an "antiartillery" safety factor beyond the necessary load-carrying strength. The concrete placing was monolithic and continuous.

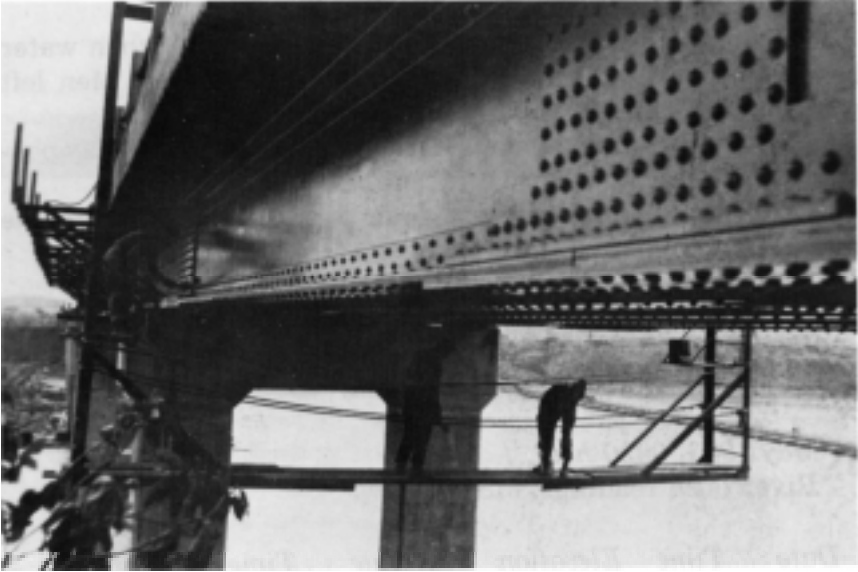
Figure 76. “Jackson’s chariot,” which could be rolled from the deck, providing scaffolding for bridge painters.
